Effect of a GPS anomaly on different GNSS receivers

Anne-Laure Vogel, Christophe Macabiau, Norbert Suard

Anne-Laure Vogel, Christophe Macabiau, Norbert Suard. Effect of a GPS anomaly on different GNSS receivers. ION GNSS 2005, 18th International Technical Meeting of the Satellite Division of The Institute of Navigation, Sep 2005, Long Beach, United States. pp 1645-1655. hal-01022185

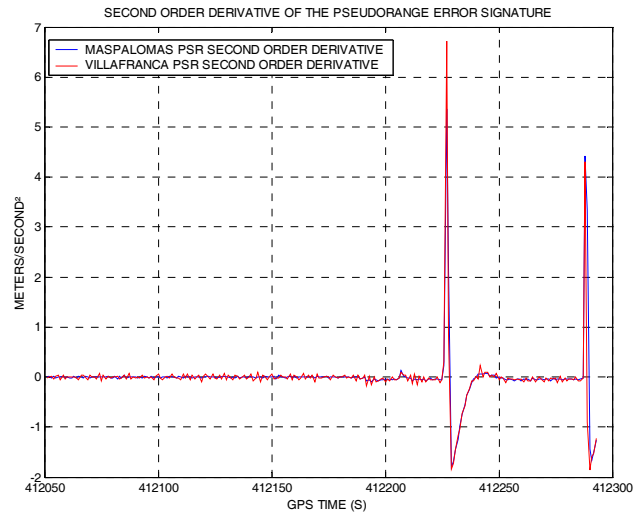
Figure 10: Second order derivative of the pseudorange error signature .

On the previous figures, two impulsions in the slope are visible. But the second one does not present exactly the same shape if we look at data coming from Villafranca or Maspalomas. In fact, the receiver in Maspalomas lost PRN23 tracking just after the second slope discontinuity and the PRN23 pseudorange could therefore have been affected in a different manner. That is why we focused our attention on the first slope discontinuity.

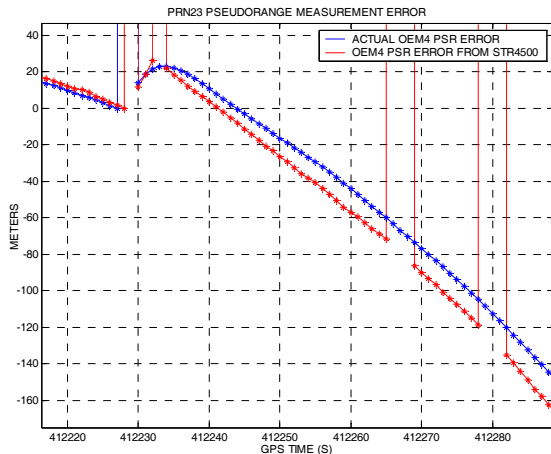
Figure 13: OEM4 PRN23 pseudorange measurement error.

Again, the shape of the two curves is very similar. The main differences are due to the fact that :

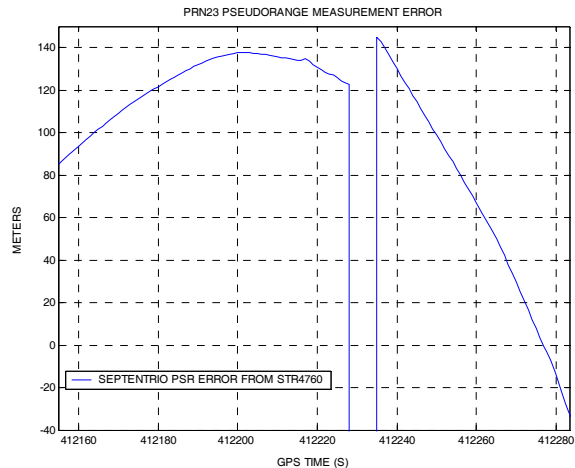
The same scenario has been used to observe the behavior of a Septentrio receiver. No real data were available to make a comparison, but with the scenario, the Septentrio also loses the PRN23 at GPS time 412229s during 6 seconds (figure 14). But when plotting the results, the problem of the estimation of the bias was worse than with the Novatel OEM4, and the divergence of the pseudorange was too large to well see the impact of the failure on the following figure.

Figure 14: Septentrio PRN23 pseudorange measurement error.
