Effect of a GPS Anomaly on Different GNSS Receivers

Anne-Laure Vogel, *Sofréavia, France*
Christophe Macabiau, *ENAC, France*
Norbert Suard, *CNES, France*

ABSTRACT

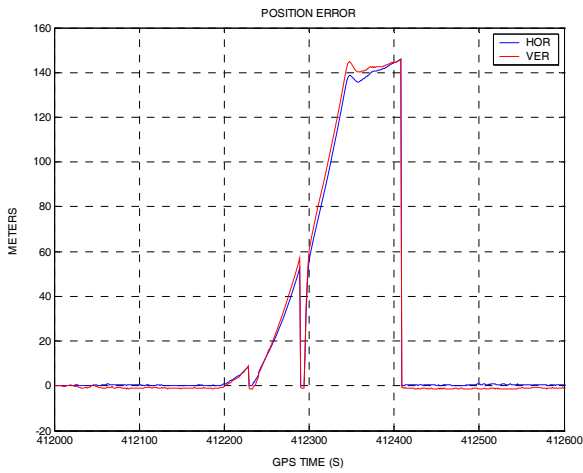
Starting from 18h29min53s (that is to say 412193 sec. in GPS time), we note that the horizontal and vertical position errors increase quickly to 150m as shown on figure 3. These values are in conformity with those observed by CNES [RD 3].

Approximately 200 seconds after the appearance of the incident (GPS time 412409s), the receiver provides positions with horizontal and vertical errors becoming again normal. It seems that the receiver fails to track the satellite 23.

Figure 3: Horizontal and vertical position error from 18h26min40s to 18h36min40s (GPS time)
