# Effect of a GPS Anomaly on Different GNSS Receivers

Anne-Laure Vogel, *Sofréavia, France*  
Christophe Macabiau, *ENAC, France*  
Norbert Suard, *CNES, France*

## ABSTRACT

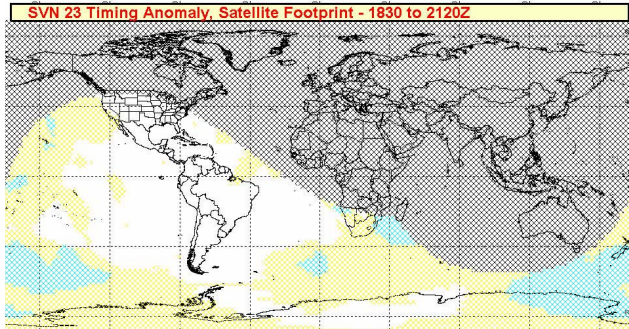
An important anomaly of the GPS system occurred on January 1, 2004, starting at around 18h30 UTC, and affecting time and position estimates on a very wide zone illustrated in figure 1.

Figure 1: Affected area shown in gray [RD1]

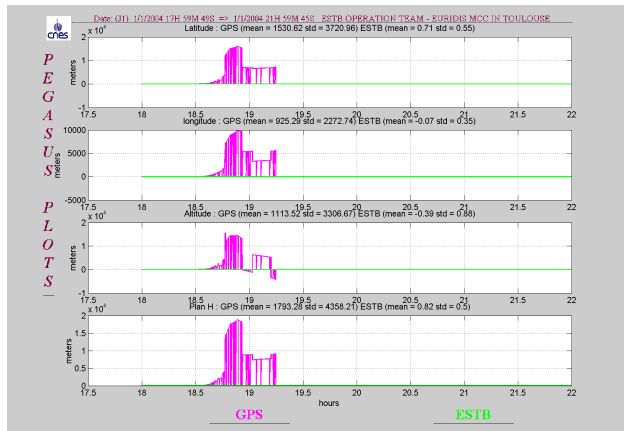
**Figure 4: Latitude, Longitude, Altitude and Horizontal errors from 18h00 to 22h00 UTC**

In this case, as the receiver of the IGN station continued tracking the satellite 23, we observe positioning errors of several km.

due to the satellite PRN 23 signal being tracked with difficulty by the receiver.

At 19h15min UTC, the receiver of the IGN station stopped to deliver PRN 23 measurements and position estimates became correct again. It is also the same phenomenon that occurred for the majority of the permanent GPS reference stations.

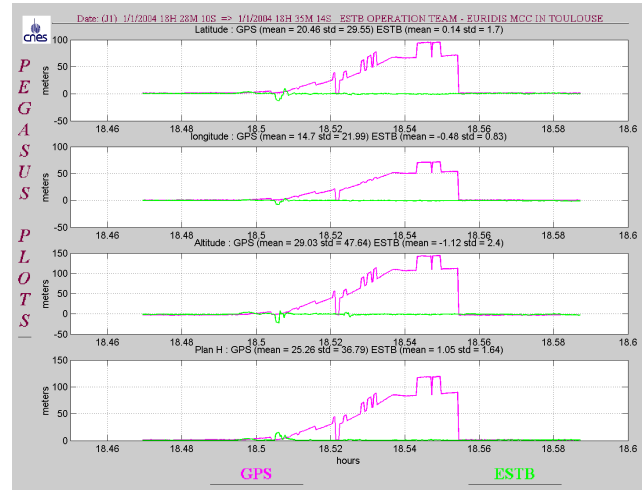
Figure 6: Positions errors (Lat, Lon, V, H) observed with ESTB (green) and GPS only (magenta) functions.

The receivers using ESTB also underwent drifts of position when the failure appeared. These errors reached a maximum of 15m in horizontal and 25m in vertical and only lasted less than 5 seconds, then the PRN23 was excluded in the internal ESTB time reference. These errors are definitely lower than those of standalone GPS receivers. Moreover, the satellite PRN23 was excluded by the ESTB system at 412228s (35 seconds after beginning of the failure).

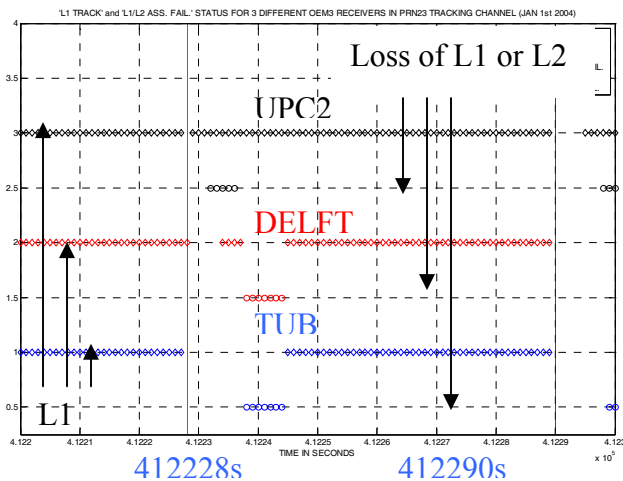
**Figure 7: PRN23 tracking status for 3 different OEM3 receivers (TUB, DELFT, UPC2).**

As we can see in this figure, TUB and UPC2 receivers lose lock at the exact same time, which is 412228s. DELFT receiver loses lock one second later, at 412229s. Then, UPC2 receiver re-locks on the signal the second after. DELFT receiver regains lock 5 seconds later at 412234s, to lose lock again at 412238s for 6 seconds. TUB receiver regains lock very late, at 412245s.

It is also interesting to note again the wide variety of behaviors of the different receivers after their loss of lock, although they were all OEM3 receivers. This can be explained by different firmware versions being run by the receivers themselves, as well as by different environmental conditions for these receivers, like noise and multipath effect at that time, but also like the number of satellites being tracked by the receiver at that time.

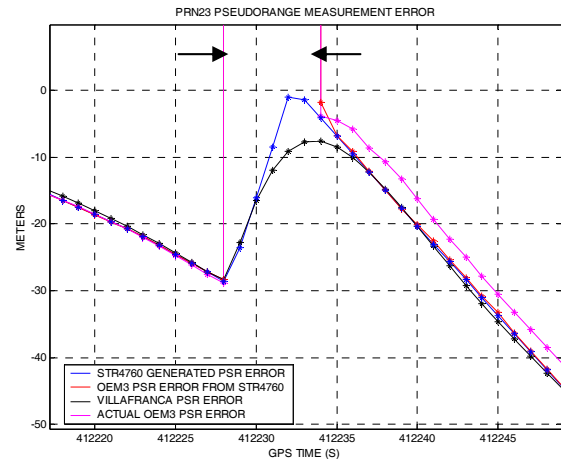
Figure 12: Zoom on PRN23 pseudorange measurement error.

- A rupture in the slope of the failure is responsible for the loss of tracking of PRN23 for the Novatel OEM3;
- The OEM3 used for the simulation effectively loses PRN23 tracking during 5 seconds before reacquiring it again which is in line with what was observed.
- The magenta curve, representing the actual OEM3 PRN23 pseudorange error, is biased after the break : in fact for these data, the clock bias was not available and the pseudorange is therefore not corrected from that error. The break may have introduced a little jump in the clock bias (about 5 meters certainly coming from a divergence of the internal clock of the receiver) explaining that this curve is not superimposed on the other ones.
