Effect of a GPS Anomaly on Different GNSS Receivers

Anne-Laure Vogel, *Sofréavia, France*
Christophe Macabiau, *ENAC, France*
Norbert Suard, *CNES, France*

ABSTRACT

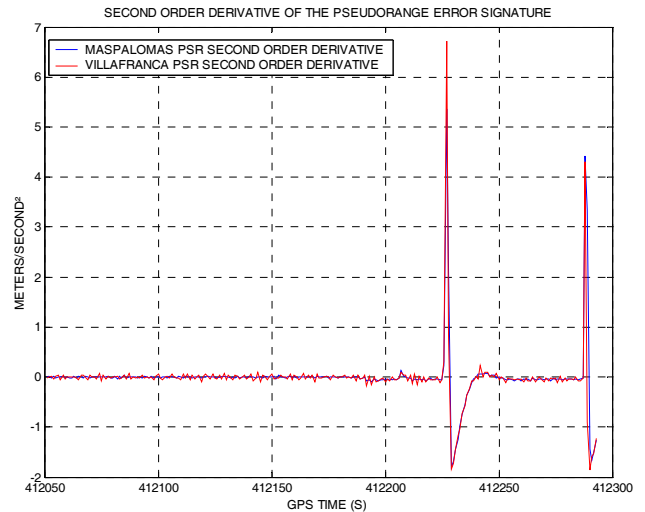
Figure 9: First order derivative of the pseudorange error signature.

Figure 10: Second order derivative of the pseudorange error signature .

On the previous figures, two impulsions in the slope are visible. But the second one does not present exactly the same shape if we look at data coming from Villafranca or Maspalomas. In fact, the receiver in Maspalomas lost PRN23 tracking just after the second slope discontinuity and the PRN23 pseudorange could therefore have been affected in a different manner. That is why we focused our attention on the first slope discontinuity.

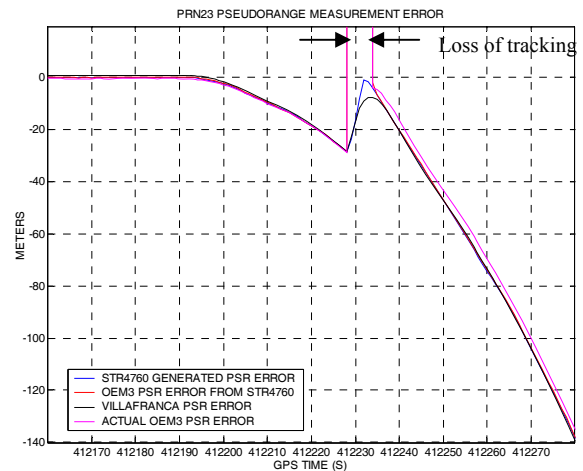
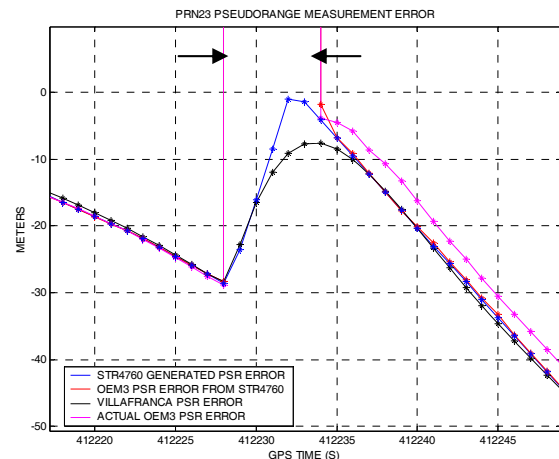
Figure 11: PRN23 pseudorange measurement error.

Figure 12: Zoom on PRN23 pseudorange measurement error.

- A rupture in the slope of the failure is responsible for the loss of tracking of PRN23 for the Novatel OEM3;
- The OEM3 used for the simulation effectively loses PRN23 tracking during 5 seconds before reacquiring it again which is in line with what was observed.
- The magenta curve, representing the actual OEM3 PRN23 pseudorange error, is biased after the break : in fact for these data, the clock bias was not available and the pseudorange is therefore not corrected from that error. The break may have introduced a little jump in the clock bias (about 5 meters certainly coming from a divergence of the internal clock of the receiver) explaining that this curve is not superimposed on the other ones.
